**Flood Control Project Maintenance
Levee Inspections**

Maintenance Issue Types Only, Levee Inspection Report By Mile - Fall 2018

Sutter Maintenance Yard East Levee Sacramento River

Waterway	Bank	Unit Miles	Inspection Start/End	Inspector
Unit No. 01 Sacramento River	Left	19.85	10/10/2018 10/10/2018	Bob Duffey

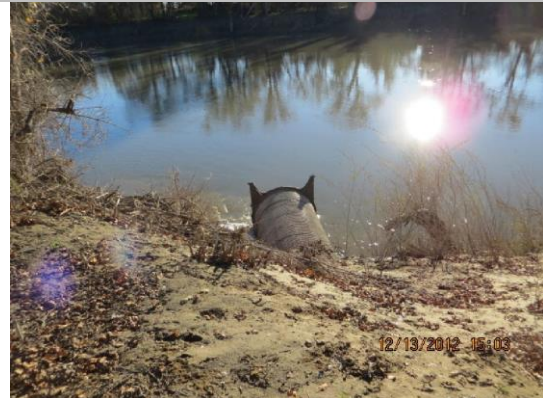
Photo 1 of 3 : UCIP_FA_2018_51650_46962.jpg

Comment Code					
Inspector Comment					
FS_ID:51650 DS_ID:17307 EP_NO: 9534 Repair Type: No Action Needed Crossing Status: Found UCIP Comments: 10/27/2017 This structure is inspected annually under the Structure and Channel Summer Inspection (part of the Levee Inspection Program) conducted by the DWR Flood Project Integrity and Inspection Branch (FPIIB). (DWR UCIP - O. Magana) 4/24/2017 Both sides of crossing were underwater during site visit. Will need to revisit after water levels drop. (DWR Sutter Yard-AFreitag) 11/7/2016 Crossing appears to be in good condition. (DWR Sutter Yard- AFreitag) 6/6/2016 Crossing appears to be in good condition. 4/6/2015 Good Condition. No issues. Semi circle CMP half riser in inlet structure on LS. Inlet opeing has no trash rack, this may cause safety issue. 6/30/2014 Same as last inspection. 12/30/2013 Same as last inspection. 7/29/2013 Same as last inspection. FIELD_STRUCT_DESC: [Butte Slough Drainage Structure] 78-inch drainage pipe of an unknown material through the levee, 3 feet below the crown. Flap gate on the waterside (WS). Corrugated metal pipe (CMP) half riser (in a semi-circle configuration) in the inlet structure on the landside (LS). (78-inch pipe [HLM 0.44] authorized under Automatic Board Order (ABO) issued as Permit No. 9534, 1974 - Caleta). [Additional Reference(s): DWR Levee Log, 2002. USACE Sacramento O&M Manual 136, March 1960 (HLM 0.44)]. FS Date: 4/26/2017 9:46:51 AM

Waterside view: overview towards CMP sewer pipe

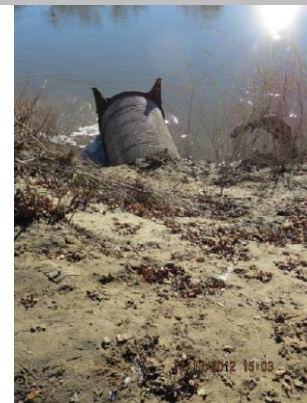
Photo 2 of 3 : UCIP_FA_2018_51650_46960.jpg

Waterside view: water flowing from CMP sewer pipe

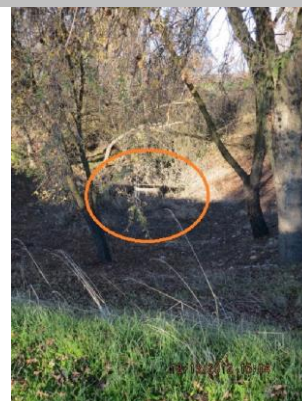
Photo 3 of 3 : UCIP_FA_2018_51650_46961.jpg

Landside view: overview

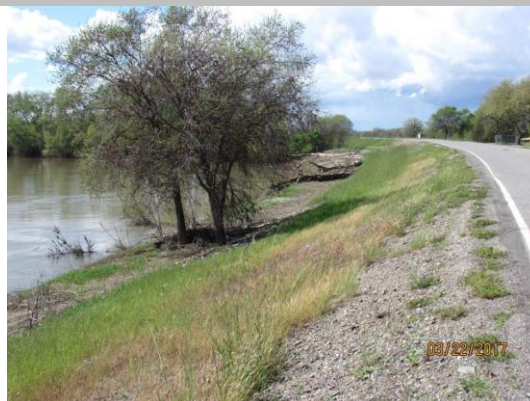
Photo 1 of 1 : FA_2018_ST0003_264_9_20180905_00007.jpg

View of the debris along the waterside slope.

LM Start	0.54	Rating **	M	Issue No.	9
LM End	0.68	Issue Type +	Ma	Location *	WS
Category	Earthen Levee			GPS Latitude/Longitude	
				Start	End
Item	Encroachments			39.197267°	39.198178°
				-121.944232°	-121.946412°
DWR ID	DWR_ST0003_01_s_2017_9				
Comment Code					
DE : Debris					
Inspector Comment					
Remove the debris from the waterside slope.

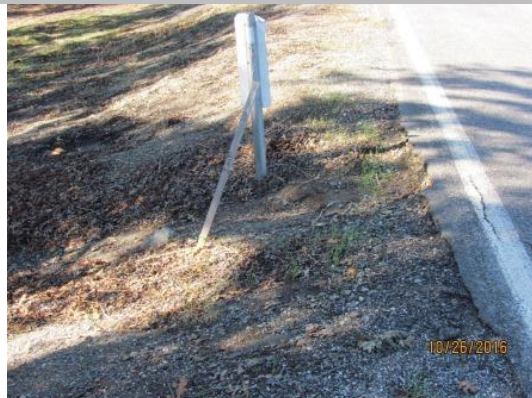
Photo 1 of 1 : FA_2018_ST0003_264_80_20180905_00018.jpg

View of the slope instability along the waterside slope.

LM Start	1.17	Rating **	M	Issue No.	80
LM End	1.17	Issue Type +	Ma	Location *	WS
Category	Earthen Levee			GPS Latitude/Longitude	
				Start	End
Item	Slope Stability			39.194126°	39.194126°
				-121.953345°	-121.953345°
DWR ID	DWR_ST0003_01_f_2016_80				
Comment Code					
S1 : Repair slope instability.					
Inspector Comment

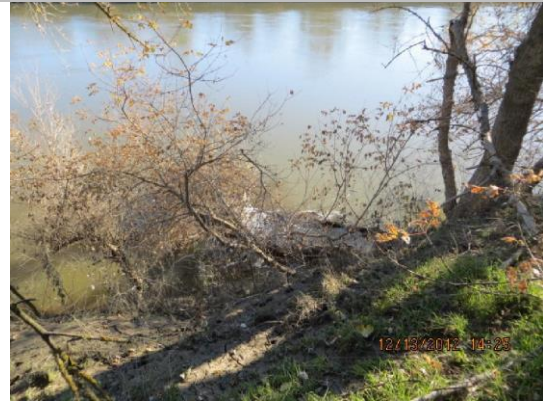
Photo 1 of 3 : UCIP_FA_2018_53400_46992.jpg

FS_ID:53400
DS_ID:17320
EP_NO: 9543
Repair Type: Urgent
Crossing Status: Found
UCIP Comments: 8/30/2018 WS vegetation too thick to clearly inspect WS pipe so assume same condition as last inspections so crossing remains Urgent due to pipe integrity. WS levee slope looks good. No signs of levee threat to the road crown. LS headwall looks in good condition (D. Sanoski - DWR UCIP).4/24/2017 WS was underwater during the site visit but I do not believe that any repairs have been made to this crossing yet. (DWR Sutter Yard- AFreitag)11/7/2016 No repairs have been made here yet. (DWR Sutter Yard- AFreitag)6/17/2016 River levels were down and the WS pipe end was exposed. WS end is completely rotten and damaged and flap gate has fallen off the end of the pipe (see pics). Pipe needs to be replaced or repaired. (DWR Sutter Yard - afreitag)4/5/2016 Erosion on WS slope still present. Pipe still fully submerged on WS and discharging into river during site visit. (DWR UCIP - kfazel)4/6/2015 Pipe leaks during high water. DWR employee said he suspects that the flap gate has rotted and fallen off WS end of pipe. Could not locate WS end of pipe to confirm. Water was flowing through this drain during field survey. (DWR Sutter Yard - afreitag)6/30/2014 Same as last inspection. (DWR Sutter Yard - afreitag)12/30/2013 Same as last inspection. (DWR Sutter Yard - afreitag)7/29/2013 Same as last inspection. (DWR Sutter Yard - afreitag) 12/13/2012 Water was flowing through this drain during field survey. (DWR UCIP - pamatya)

FIELD_STRUCT_DESC: 30-inch corrugated metal drainage pipe (at 45 degrees) through the levee, 25.2 feet below the crown. Flap gate on the waterside (WS), not found in 2016. (30-inch pipe [HLM 1.38] authorized under Automatic Board Order (ABO) issued as Permit No. 9543, 1974 - Harada). [Additional Reference(s): DWR Levee Log, 2002. USACE Sacramento O&M Manual 136, revision March 1960 (HLM 1.38)]
FS Date: 8/30/2018 1:02:00 PM

Waterside view: overview of river bank

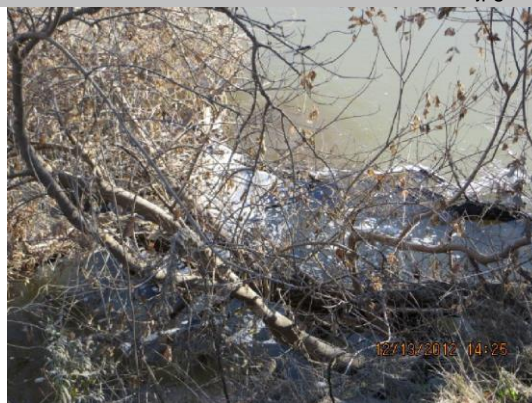
Photo 2 of 3 : UCIP_FA_2018_53400_46991.jpg

Waterside view: water flowing from outlet pipe (pipe fully submerge)

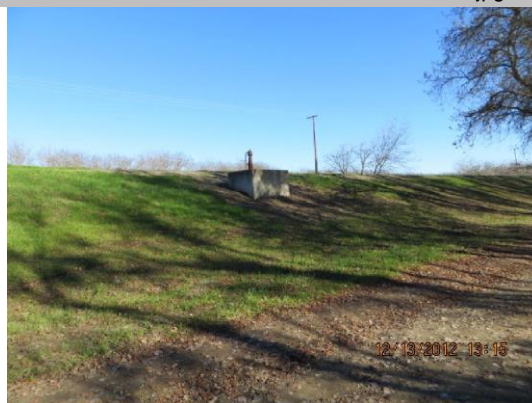
Photo 1 of 3 : UCIP_FA_2018_51660_47027.jpg

Comment Code						
Inspector Comment						
FS_ID:51660 DS_ID:17309 EP_NO: 9541 Repair Type: Non-Urgent Crossing Status: Found UCIP Comments: 4/24/2017 Still no sign of WS pipe end or flapgate. LS appears to be in good condition. (DWR Sutter Yard- AFreitag) 11/7/2016 LS culvert measured to be 30"wide X 30"tall. WS end is not visible so could not be measured. (DWR Sutter Yard- AFreitag)6/6/2016 Cannot locate the WS headwall/flapgate. Appears to have been silted over.4/6/2015 Same as last inspection. Concrete surg box on WS. Flap gate in concrete "U" headwall at the waterward end- not found.6/30/2014 Same as last inspection.12/30/2013 Same as last inspection.7/29/2013 Same as last inspection. FIELD_STRUCT_DESC: 30-inch reinforced concrete box drainage culvert through the levee, 14.3 feet below the crown. 30-inch corrugated metal pipe connects concrete culvert from slide gate out to flap gate on the waterside (WS) end. Slide gate in a concrete riser on the waterside (WS) slope. (30-inch pipe [HLM 2.49] authorized under Automatic Board Order (ABO) issued as Permit No. 9541, 1974 - Wilbur, McGowan, Zinke). [Additional Reference(s): DWR Levee Logs, 2002. USACE Sacramento O&M Manual 136, March 1960 (HLM 2.49)]. FS Date: 4/26/2017 10:46:22 AM

Waterside view: overview- concrete surg tank

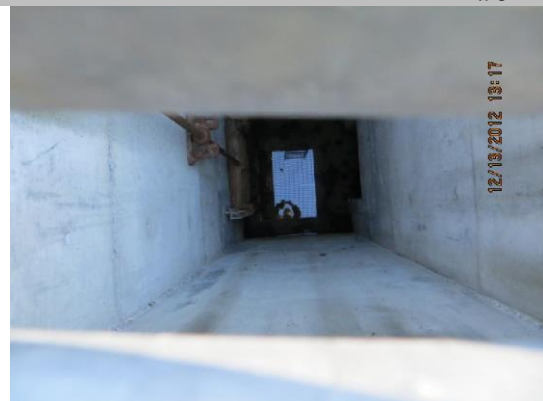
Photo 3 of 3 : UCIP_FA_2018_51660_47025.jpg

Waterside view: slide gate inside concrete surg tank

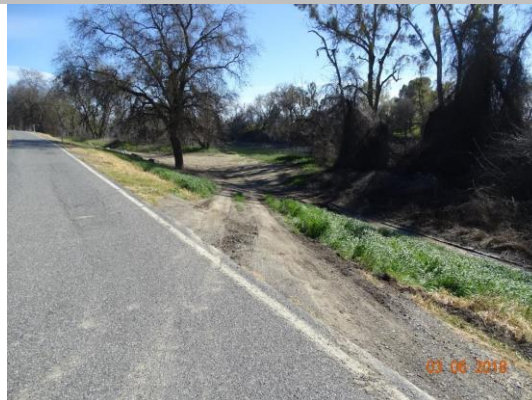
Photo 1 of 1 : FA_2018_ST0003_264_104_20180905_00024.jpg

View of the erosion along the waterside slope caused by vehicle traffic.

LM Start	2.84	Rating **	M	Issue No.	104
LM End	2.84	Issue Type +	Ma	Location *	WS
Category	Earthen Levee			GPS Latitude/Longitude	
				Start	End
Item	Slope Stability			39.191162 °	39.191162 °
				-121.980365 °	-121.980365 °
DWR ID	DWR_ST0003_01_s_2018_104				
Comment Code					
S3 : Repair the levee slope damaged by vehicle traffic and prevent access where possible.					
Inspector Comment					
Repair the erosion along the water side slope caused by vehicle traffic.

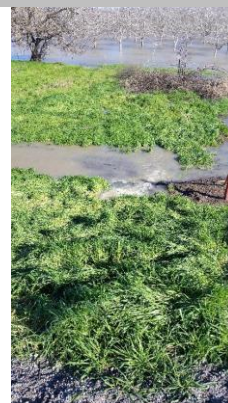
Photo 2 of 3 : UCIP_FA_2018_52949_76920.jpg

Comment Code						
Inspector Comment						
FS_ID:52949 DS_ID:17311 EP_NO: N/A Repair Type: Urgent Crossing Status: Found UCIP Comments: 8/30/2018 Pipe found; at a different Lat/Long than is listed, however. Revised Lat/Long is (39.196865, -121.985280; CLM 3.32). WS pipe end is visible and has a functioning slide gate; LS pipe end is exposed with no closure device or headwall. Keeping as Urgent because the LS pipe discharges into a hole and could pose a threat to the levee prism during a high water event. There are also cracks on the crown that could be related to the pipe beneath. Recommend an internal pipe inspection to be sure of the levee integrity (D.Sanoski - DWR UCIP).4/6/2017 Pipe was found in January 2017 during a high water event when water uncovered the buried WS end which led to uncontrolled water flow through during the high water event. The WS pipe opening was temporarily blocked off by plywood and sandbags until the pipe can be properly plugged or abandoned. Pics updated. (DWR Sutter Yard- Afreitag)11/7/2016 Unable to locate. (DWR Sutter Yard- AFreitag)6/6/2016 Unable to locate.4/6/2015 Unable to locate.6/30/2014 Unable to locate.12/30/2013 Unable to locate.7/29/2013 Same as last inspection. Unable to locate. FIELD_STRUCT_DESC: 24-inch corrugated metal drainage pipe through the levee, 12.4 feet below the crown. Slide gate on the waterside (WS) end. (Automatic Board Order (ABO) issued as Permit No. 9539, 1974 - Locvich). [Additional Reference(s): DWR Levee Log, 2002. USACE Sacramento O&M Manual 136, March 1960 (HLM 3.25)]. FS Date: 8/30/2018 1:45:35 PM

LS view from levee shoulder

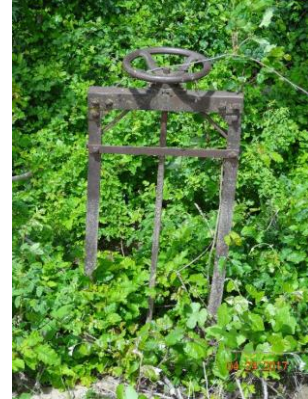
Photo 1 of 2 : UCIP_FA_2018_51666_77004.jpg

Comment Code					
Inspector Comment					
FS_ID:51666 DS_ID:17313 EP_NO: N/A Repair Type: Non-Urgent Crossing Status: Found UCIP Comments: 4/24/2017 Slide gate structure found on WS about 10ft from levee toe. Vegetation was too thick to see if there were any more appurtances associated with this crossing visible on the WS. Nothing was visible on the LS. House located above pipe alignment at LS levee toe. Crossing appears abandoned and should be done so properly. (DWR Sutter Yard- A Freitag)11/7/2016 Unable to locate. (DWR Sutter Yard- A Freitag)6/6/2016 Unable to locate.4/6/2015 Unable to locate.6/30/2014 Unable to locate.12/30/2013 Unable to locate7/29/2013 Same as last inspection. Unable to locate. FIELD_STRUCT_DESC: *ABANDONED* 18-inch corrugated metal drainage pipe through the levee, 15 feet below the crown. Slide gate on the waterside (WS) end. [Additional Reference(s): DWR Levee Log, 2002. USACE Sacramento O&M Manual 136, March 1960 (HLM 3.6)]. FS Date: 4/26/2017 12:11:41 PM

Slide gate structure found on WS

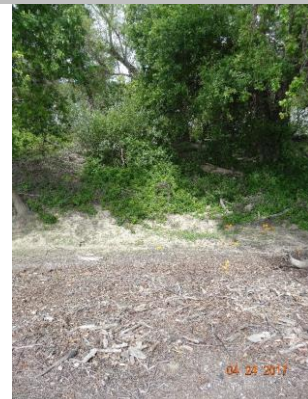
Photo 2 of 2 : UCIP_FA_2018_51666_77005.jpg

View of WS from levee shoulder

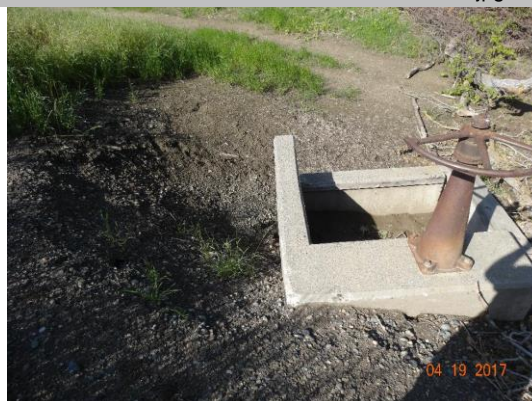
Photo 1 of 3 : UCIP_FA_2018_51695_77008.jpg

FS_ID:51695
DS_ID:17301
EP_NO: 9532
Repair Type: Non-Urgent
Crossing Status: Found
UCIP Comments: 4/19/2017 Abandoned- erosion/depression present around the WS box (DWR Sutter Yard- AFreitag)10/31/2016 Abandoned and erosion still present near WS box.(DWR Sutter Yard- AFreitag)6/1/2016 Appears to be an abandoned crossing.4/1/2015 Silted concrete box on WS. Depression/erosion around concrete box on WS.Silted concrete box on WS. Depression/erosion around concrete box on WS.6/30/2014 Same as last inspection.12/18/2013 Same as last inspection.7/23/2013 Same as last inspection.
FIELD_STRUCT_DESC: *ABANDONED* 36-inch by 48-inch reinforced concrete box drainage culvert through the levee, 11.6 feet below the crown. Slide gate in a concrete box on the waterside (WS) slope. (3-foot by 4-foot culvert [HLM 7.73] authorized under Automatic Board Order (ABO) issued as Permit No. 9532, 1974 - Martin). [Additional Reference(s): DWR Levee Log, 2002. USACE Sacramento O&M Manual 136, March 1960 (HLM 7.73)].

Depression around WS concrete box

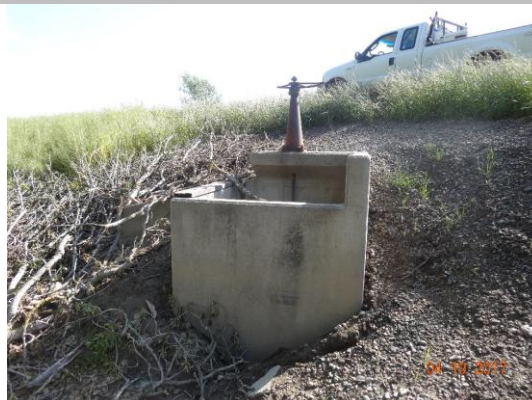
Photo 2 of 3 : UCIP_FA_2018_51695_77009.jpg

depression around WS concrete box

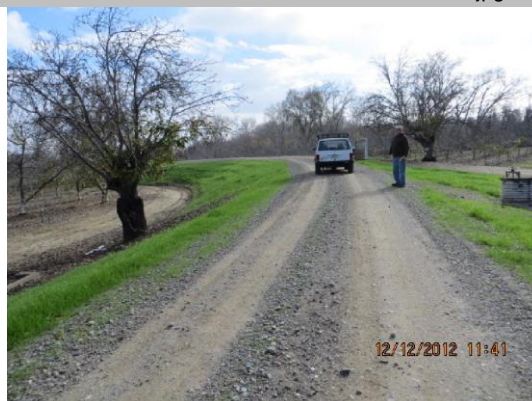
Photo 1 of 3 : UCIP_FA_2018_51698_47202.jpg

Comment Code					
Inspector Comment					
FS_ID:51698 DS_ID:17304 EP_NO: 9529 Repair Type: Non-Urgent Crossing Status: Found UCIP Comments: 4/19/2017 Abandoned- needs to be done properly. (DWR Sutter Yard- AFreitag)10/31/2016 Abandoned (DWR Sutter Yard- Afreitag)6/1/2016 Abandoned- only WS riser and slide gate found.4/1/2015 CMP riser and slide gate on WS. LS distribution box is silted in. Looks abandoned. CMP riser with slide gate on WS. Concrete distribution box on LS- full with silt.6/30/2014 Same as last inspection.12/18/2013 Same as last inspection.7/23/2013 Same as last inspection. FIELD_STRUCT_DESC: *ABANDONED* 24-inch corrugated metal drainage pipe through the levee, invert 12.8 feet below the crown. Slide gate in a corrugated metal pipe (CMP) riser on the waterside (WS) slope. Concrete box at the landside (LS) toe. (24-inch pipe [HLM 8.35] authorized under Automatic Board Order (ABO) issued as Permit No. 9529, 1974 - Dorwood Ranching Company). [Additional Reference(s): DWR Levee Log, 2002. USACE Sacramento O&M Manual 136, March 1960 (HLM 8.35)]. FS Date: 4/26/2017 2:54:54 PM

Crown view: overview (both sides of the levee)

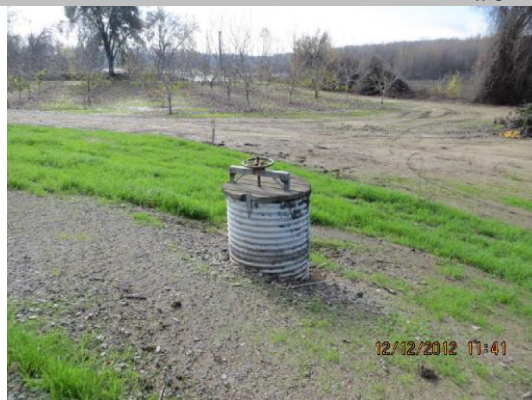
Photo 2 of 3 : UCIP_FA_2018_51698_47201.jpg

Waterside view: overview of CMP riser

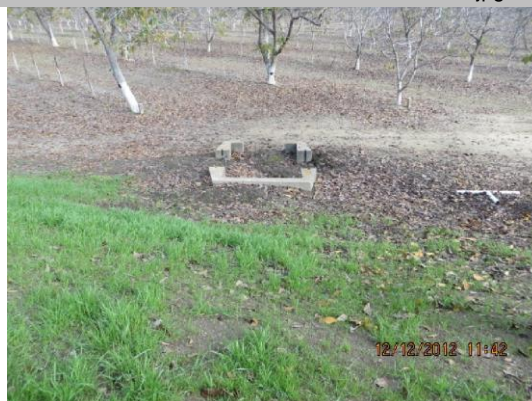
Photo 3 of 3 : UCIP_FA_2018_51698_47200.jpg

Landside view: overview of concrete box

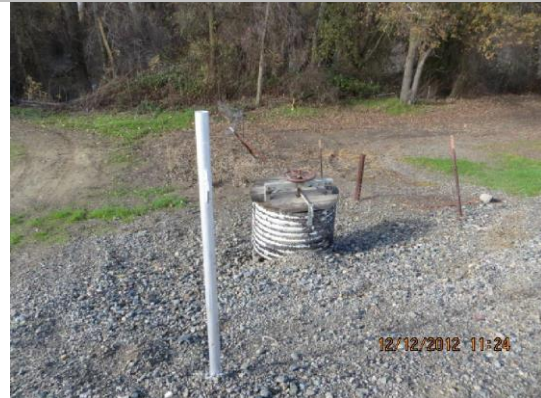
Photo 1 of 3 : UCIP_FA_2018_51725_47208.jpg

FS_ID:51725
DS_ID:17295
EP_NO: 9529
Repair Type: No Action Needed
Crossing Status: Found
UCIP Comments: 09/21/2017 Permit review indicates this 24-inch pipe was authorized as an irrigation and drainage pipe under ABO issued as Permit No. 9529, structure description was updated. Structure type logged as drainage. (DWR UCIP - O. Magana)
4/19/2017 Abandoned- needs to be done so properly. (DWR Sutter Yard- Afreitag)10/31/2016 Abandoned. (DWR Sutter Yard- Afreitag)6/13/2016 Pipe was exposed and camera inspected by Nor-Cal Pipeline Services 10/29/2015. Photos of the exposed pipe ends were uploaded on 4/1/2015. The internal inspection showed some signs of rust but no visible holes or deterioration were found. After the inspection the pipe ends were capped and reburied.6/9/2016 Khalida Fazel of UCIP requests that any photos of the pipe when it was exposed for a video inspection be kindly uploaded here.4/4/2016 Proper abandonment of pipe is needed. Pipe has been buried again after it was dug up and video inspected, so was not visible on LS. Note that landowner has regraded LS slope so drainage is now to the east (toward LS).4/1/2015 Both WS and LS pipe ends have been dug up in preparation for an internal camera inspection. Pipe shows signs of heavy rust and both ends of pipe are plugged with soil.Only a CMP riser with slide gate found on WS.6/30/2014 Same as last inspection.12/18/2013 Same as last inspection.7/23/2013 Same as last inspection.

Waterside view: overview of CMP riser

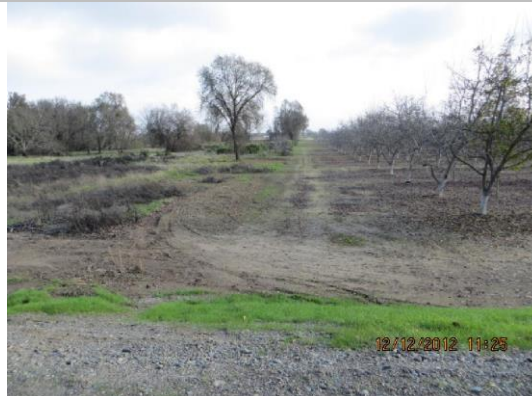
Photo 2 of 3 : UCIP_FA_2018_51725_47207.jpg

Landside view: overview (no pipes)

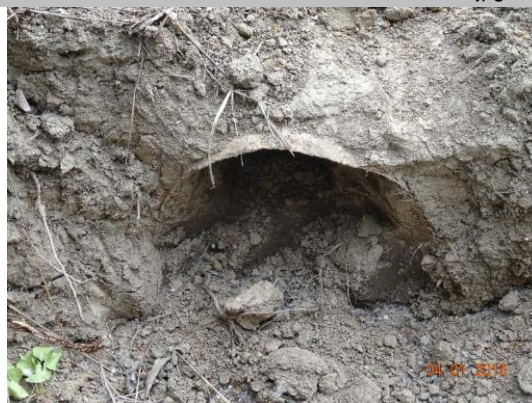
Photo 3 of 3 : UCIP_FA_2018_51725_73640.jpg

WS pipe end

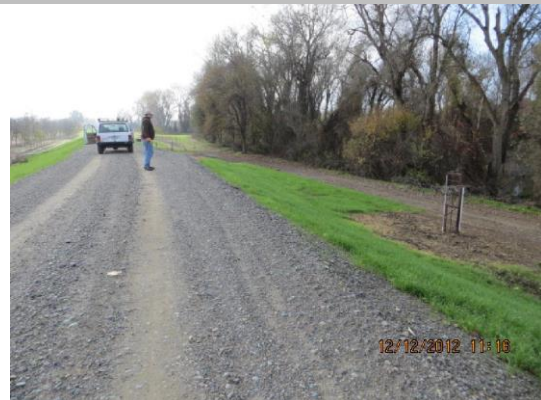
Photo 1 of 3 : UCIP_FA_2018_51726_47210.jpg

FS_ID:51726
DS_ID:17327
EP_NO: 9528
Repair Type: Non-Urgent
Crossing Status: Found
UCIP Comments: 4/19/2017 Abandoned- needs to be done so properly. (DWR Sutter Yard- Afreitag)10/31/2016 Abandoned. (DWR Sutter Yard- Afreitag)6/13/2016 Pipe was internally cleaned and camera inspected by Nor-Cal Pipeline Services on 10/29/2015. Pipe length through levee is 75.1ft long. The inspection showed some signs of rust but no holes or other deterioration were found. Pics of exposed pipe ends were uploaded on 4/1/2015. After the inspection the pipe ends were capped and reburied.4/14/2016- Same as last inspection.4/1/2015- Both ends of pipe have been dug up in preparation for internal camera inspections. Pipe shows some rust but appears to be in decent shape. Only buried slide gate structure found.6/30/2014- Same as last inspection.12/18/2013 Same as last inspection.7/23/2013 Same as last inspection.
FIELD_STRUCT_DESC: *ABANDONED* 24-inch corrugated metal drainage pipe through the levee, 12.5 feet below the crown. Slide gate on the waterside (WS). (Automatic Board Order (ABO) issued as Permit No. 9528, 1974 - Lamb). [Additional Reference(s): DWR Levee Log, 2002. USACE Sacramento O&M Manual 136, March 1960 (HLM 8.59)].

Waterside view: overview

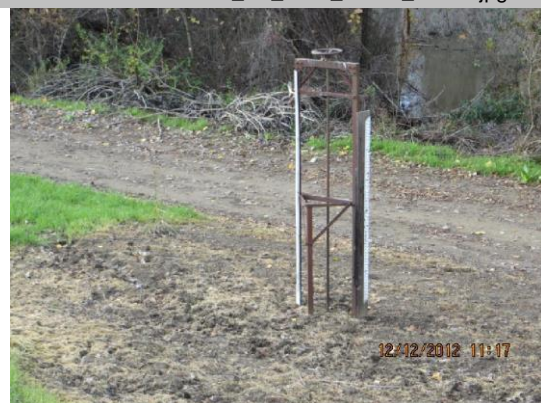
Photo 2 of 3 : UCIP_FA_2018_51726_47209.jpg

Waterside view: buried slide gate

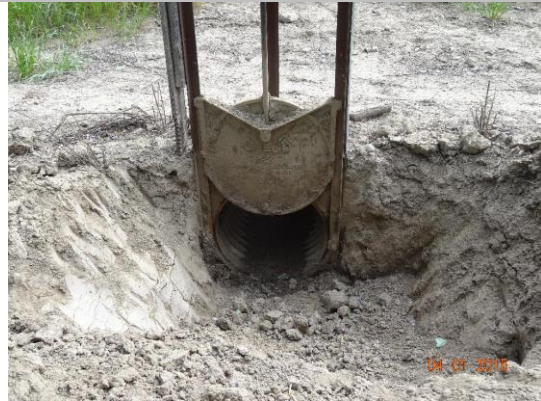
Photo 3 of 3 : UCIP_FA_2018_51726_73649.jpg

WS pipe end

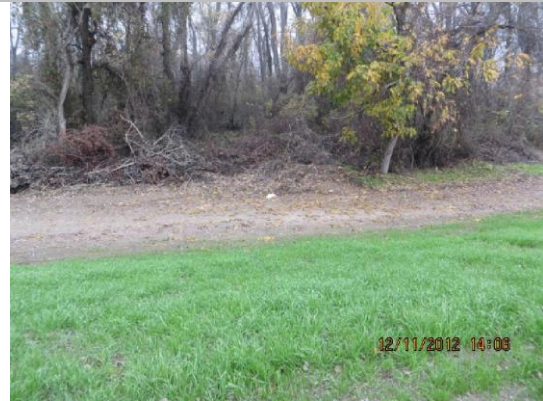
Photo 1 of 3 : UCIP_FA_2018_51731_47242.jpg

Comment Code						
Inspector Comment						
FS_ID:51731						
DS_ID:17355						
EP_NO: N/A						
Repair Type: No Action Needed						
Crossing Status: Found						
UCIP Comments: 4/19/2017 Abandoned- needs to be done so properly. (DWR Sutter Yard- Afreitag)10/31/2016 Abandoned. (DWR Sutter Yard- Afreitag)6/13/2016 Pipe was internally cleaned and camera inspected on 10/30/2015 by Nor-Cal Pipeline Services. WS cap was removed and 100.6ft of pipe were inspected starting from the WS opening. Inspection revealed rusting but no visible holes or other deterioration were found. Pipe was recapped after the inspection. This pipe is always visible so no new photos were taken during the inspection.6/9/2016 Khalida Fazel of UCIP requests that any photos of the pipe when it was exposed for a video inspection be kindly uploaded here.4/1/2015 Pipe is in same condition. It has been selected for an internal camera inspection. New CMP pipe on WS capped with steel plate.6/30/2014 Same as last inspection.12/18/2013 Same as last inspection.7/23/2013 Same as last inspection.

Waterside view: overview

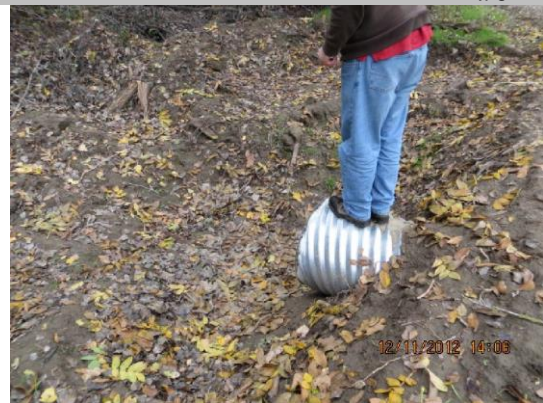
Photo 2 of 3 : UCIP_FA_2018_51731_47241.jpg

Waterside view: overview of CMP pipe

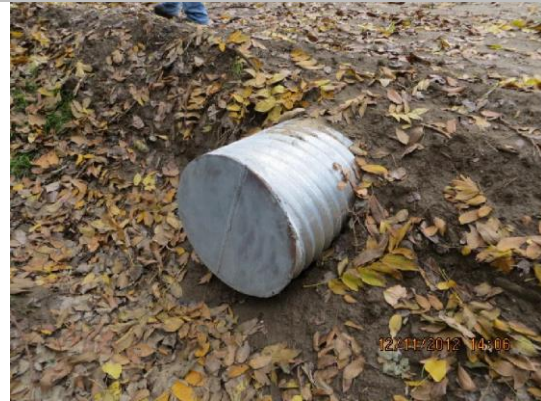
Photo 3 of 3 : UCIP_FA_2018_51731_47240.jpg

Waterside view: capped CMP pipe

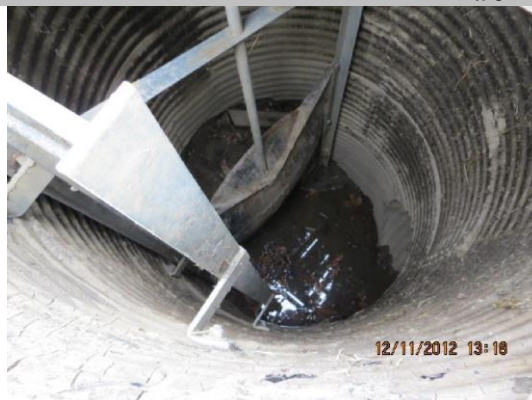
Photo 3 of 3 : UCIP_FA_2018_51734_47268.jpg

Waterside view: inside CMP riser

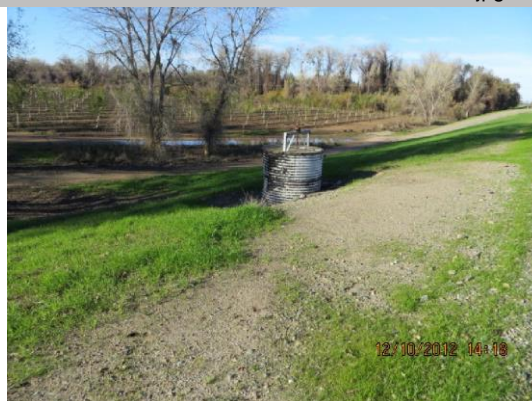
Photo 1 of 3 : UCIP_FA_2018_51749_47343.jpg

Waterside view: CMP riser with slide gate

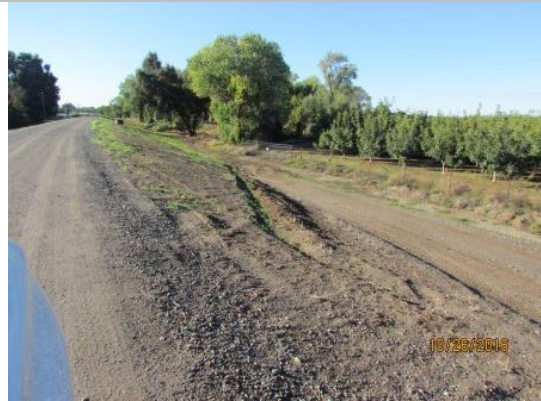
Photo 1 of 1 : FA_2018_ST0003_264_75_20180905_00016.jpg

View of the slope instability along the waterside slope.

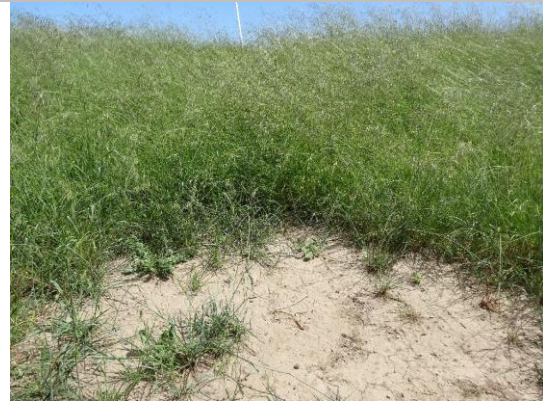
Photo 3 of 3 : UCIP_FA_2018_51759_75098.jpg

Looking up WS slope: bare spot where pipe was previously excavated, video inspected, and backfilled.

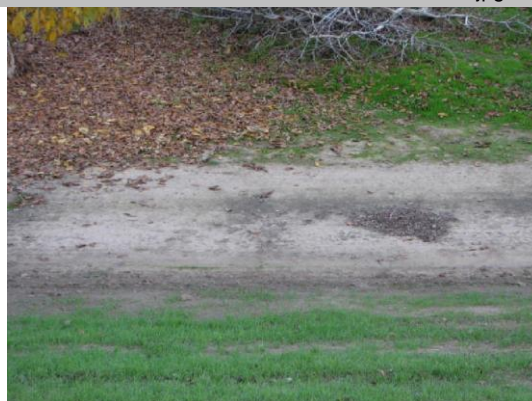
Photo 1 of 3 : UCIP_FA_2018_51762_47384.jpg

Landside view: overview. No pipe found.

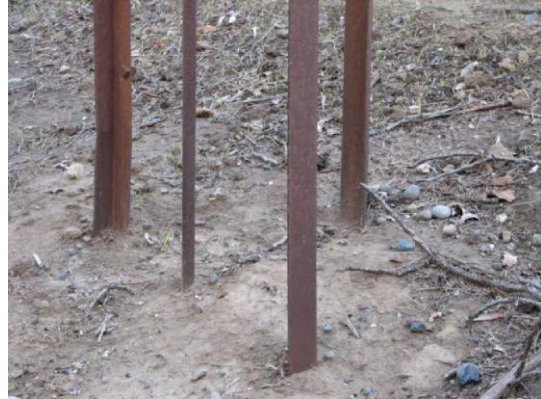
Photo 3 of 3 : UCIP_FA_2018_51762_47385.jpg

Waterside view: buried slide gate

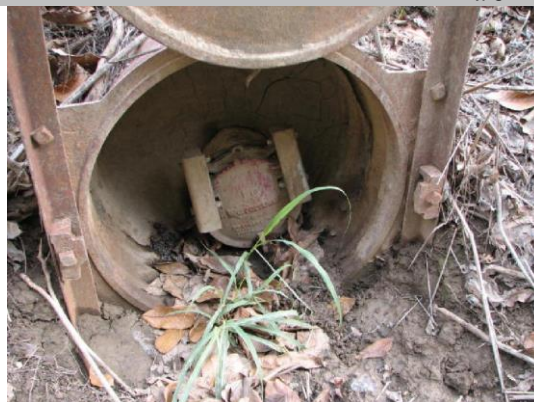
Photo 2 of 3 : UCIP_FA_2018_51771_47441.jpg

Waterside view: 8-inch pipe inside 24-inch CMP

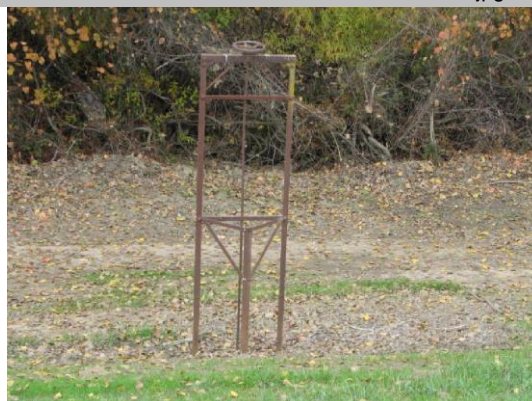
Photo 1 of 3 : UCIP_FA_2018_51773_47447.jpg

Waterside view: overview of abandoned slide gate structure

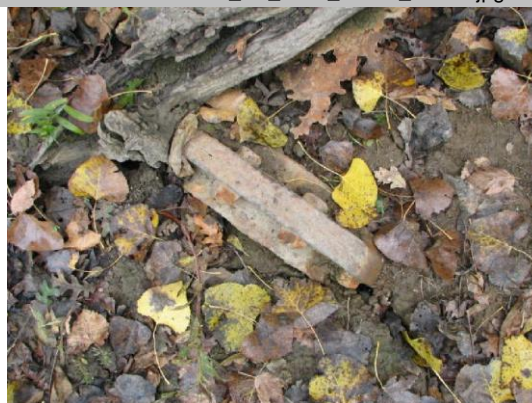
Photo 2 of 3 : UCIP_FA_2018_51775_47448.jpg

Waterside view: abandoned and ruined pipe

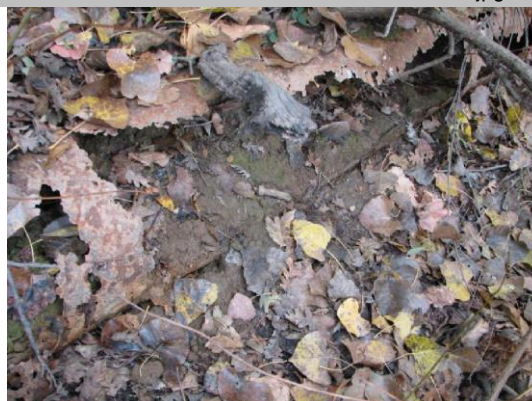
Photo 3 of 3 : UCIP_FA_2018_51775_47453.jpg

Waterside view: abandoned and ruined pipe
